Landscape-Ecological Study of the Area of European Importance

SKUEV0075 Klátovské Branch

**IMPROVEMENT OF THE WETLAND
CONDITION OF THE KLÁTOVSKÉ BRANCH NPR
ON THE TERRITORY OF SKUEV0075**

Ľuboš Jurík et al.
Nitra 2024

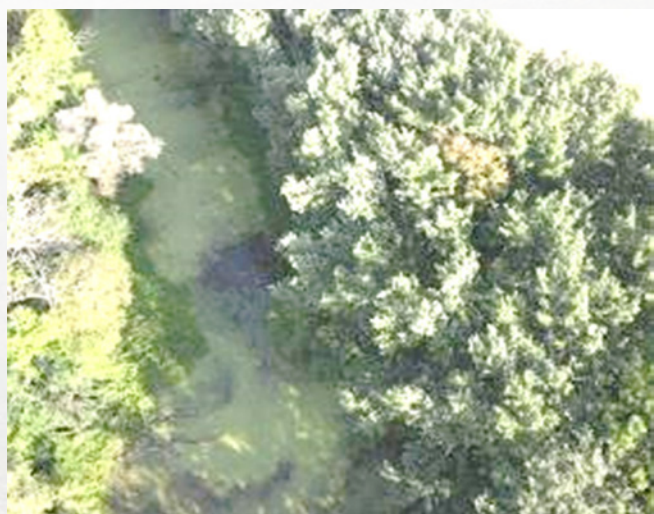
Figure 3.2 In summer, shallow and almost stagnant pools of water are covered with a mixture of algae and Lemna (*Lemna*)

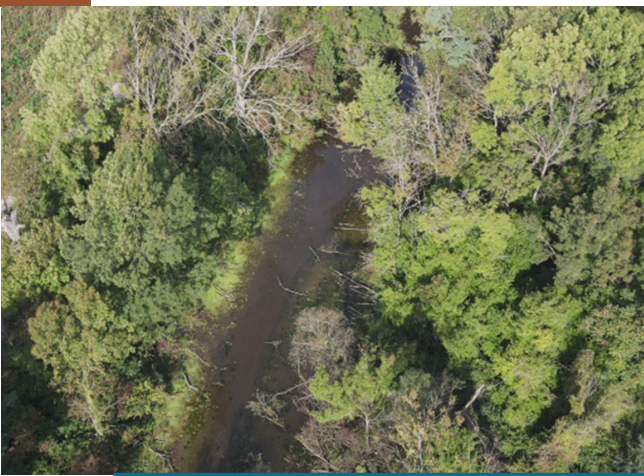
Figure 3.3 Shoals gradually overlapping with dense aquatic vegetation

Shoals are gradually becoming overgrown with dense aquatic vegetation, narrowing the flow area. Shoals also form between fallen dead trees. On the one hand this deteriorates the quality of water, on the other hand the narrowed riverbed can better convey

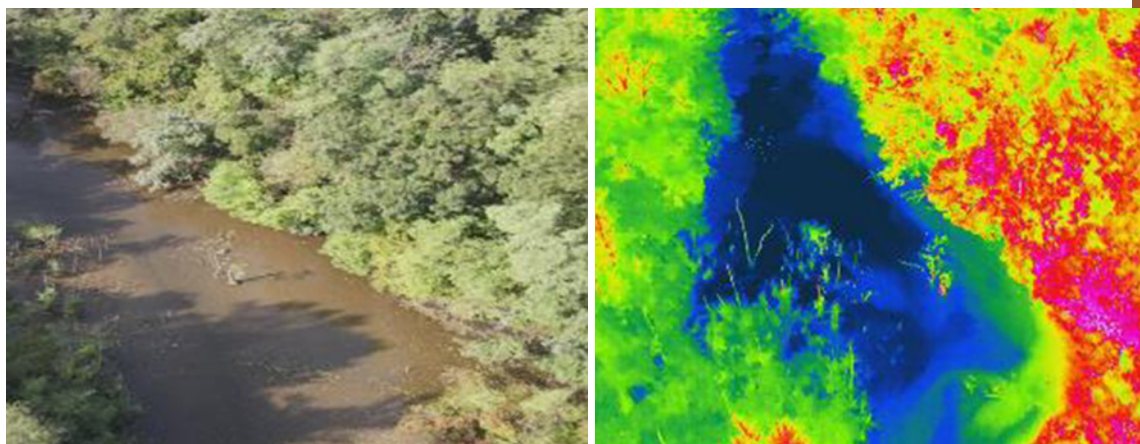
In Figures 3.5 the vistream bottom is an advanced riverbed clog with a large width and a small velocity. The riverbed siltation is so large that the first trees have taken hold here. Trees are the warmest in the riverbed

Figure 3.5 Aerial and thermal image of shallows

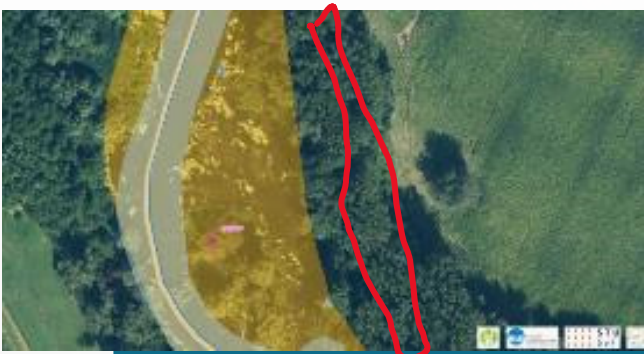
At the end of section u is now emerged the island with a small part of the flow rate which was formed on the convex riverbank arch. Settlement in this part of the arch is natural. But due to the condition of the branch, the shape of the island needs to be sculpted to create better bypass conditions and thus safety for nesting birds. As figured the solution is to simply move the sediments and also the dead wood.

Figure 4.3 Proposal for the location of the extension of the islets to the location of the sediments

Dredging the riverbed by moving sediment will cool the stream and if the original gravel stream bottom is exposed it will also create conditions for fish spawning. Dropped trees in the area also need to be addressed and directed in the direction of the flow of water so that they are not perpendicular to the flow rate. Deadwood would remain in the stream but so as not to reduce flow rate and increased sedimentation in their vicinity.

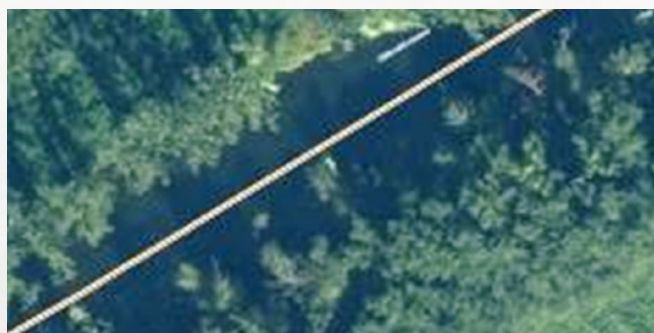
The critical condition is in the section of the arch at the top of the figure where the sediment deposits almost completely dam the flow rate in the reach. This condition is probably related to the tributary water from the Gabčíkovo – Topoľníky channel, whose quality is significantly different compared to the quality of water in the arm itself and this causes increased sedimentation. River bed in arch with alluvium forming extensive the island.

Figure 4.4 Proposed solution for moving sediments in the riverbed

At this section, future upstream bottoming is needed to detail the rate of sediment development and the potential for fish barrier formation.

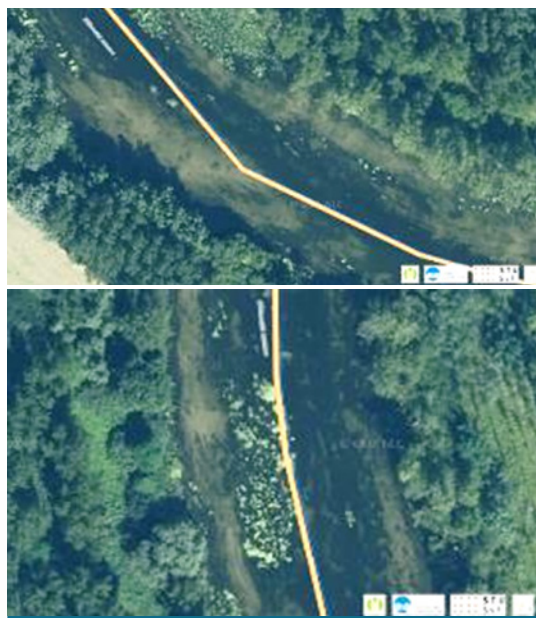
Figure 4.5 Proposal to address the need for sediment transfer in the riverbed

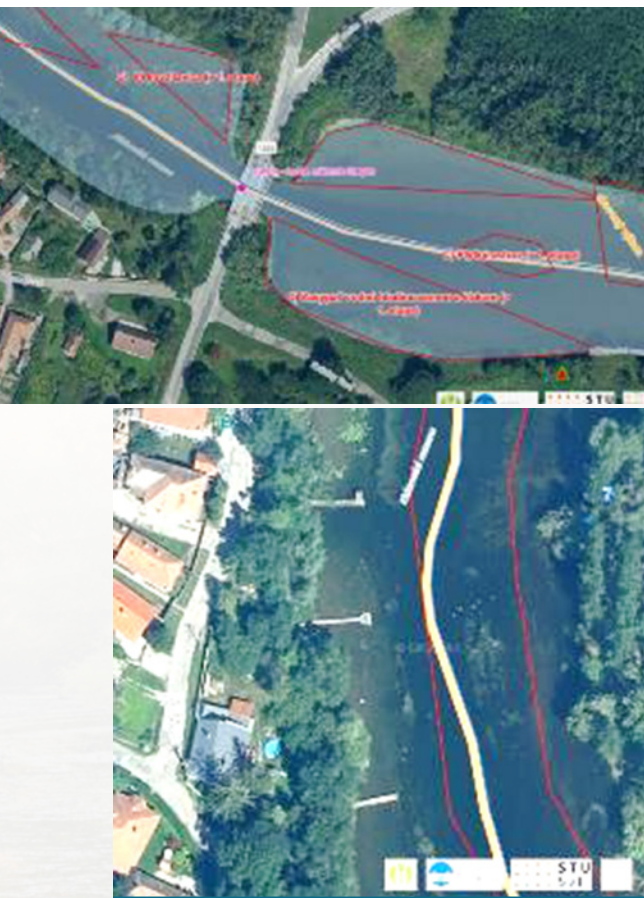
In almost the entire section the width of the riverbed itself is considerably narrower than in the previous sections. The riverbed is 20 to 25 m wide. Only at the beginning of the section is there a kind of artificial widening and then the flow narrows.

Figure 4.7 Proposed solution for moving sediments in the riverbed and creating gravel benches

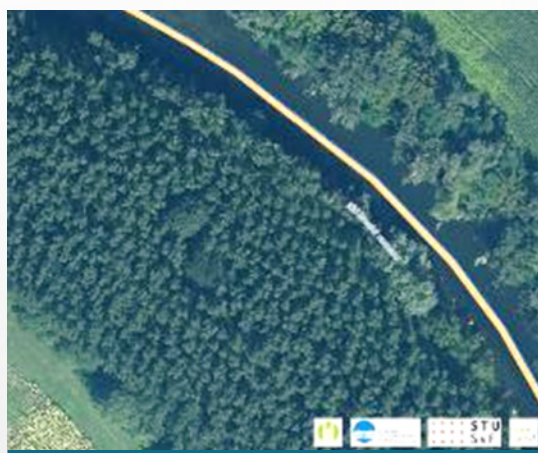
The situation is bad in the middle of this section in two places.

Figure 4.8 Suggestion of places to address for the transfer of sediments in the riverbed

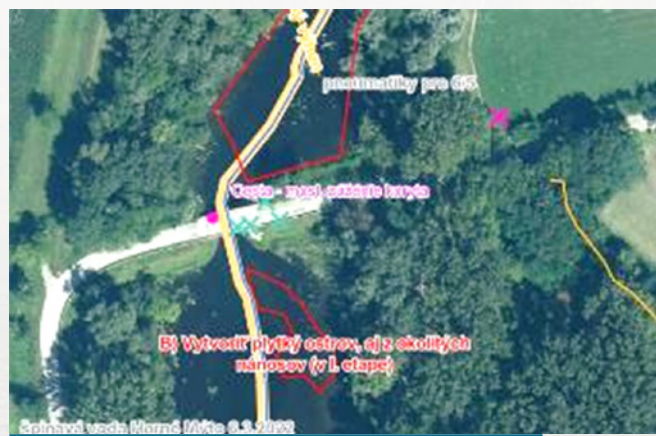
The second place in this section u to revitalize is the transverse the bridge and its surroundings. Like the other the bridges it is from the 1960's and was very insensitively built and has significantly narrowed the riverbed and of course changed the flow rate of water. Replacing the bridge is unrealistic

Figure 4.11 Proposed solution for moving sediments in the riverbed and creating gravel benches

by the measure and therefore it is advisable to create flow conditions by reshaping the riverbed by creating backfill edges in front of and behind the bridge. The stream bed in this area is gravelly and therefore this gravelly bed can be compacted by placing gravel in places as in the following figure. Moving sediment would reduce the importance of the gravel as a self-cleaning area in the water.

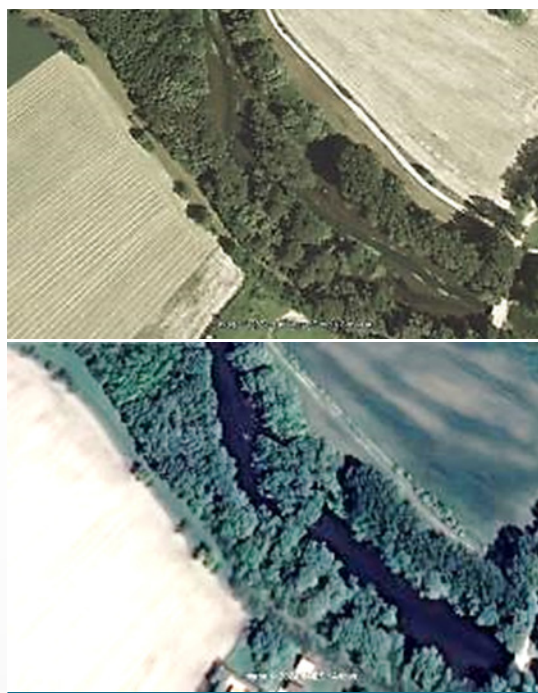
Figure 4.15 Difference in sediment volume between 2006 and 2014 (Google maps)

As the only option in this section is to move the sediments to one side. Most of the sediment is on the left side of the stream and therefore the right side of the sediment needs to be addressed. The flow regime needs to be addressed here and the last dropped trees need to be rerouted first. This measure is necessary.

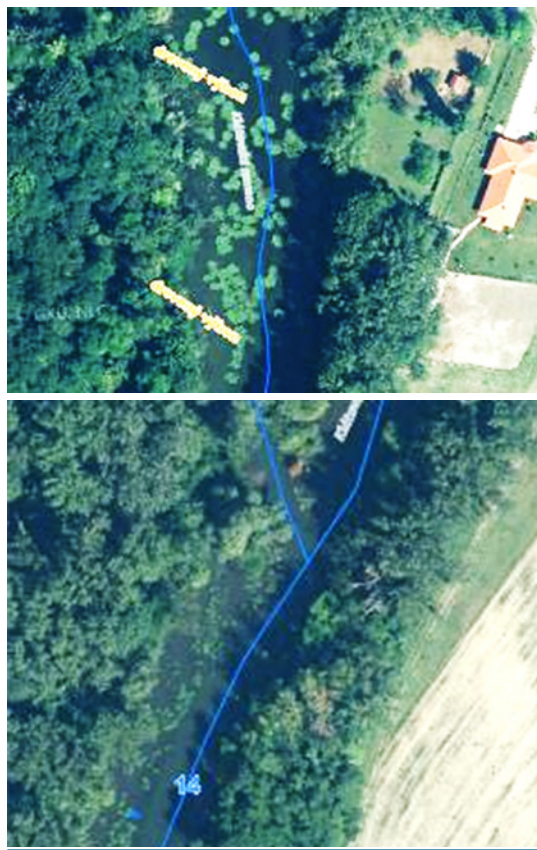
The second significant influence on the flow rate and condition of Clats Branch in this section is the Clats Mill. It is a preserved mill as an example of a mill with so-called spostream bottom water. There is a short embankment channel to provide tributary of water to the mill and a sluice gate was constructed long ago to raise the level of water. Today it is no longer functional and the water flow cannot be regulated. As the mill is only a museum, the justification for a sluice gate should be discussed. As a result, it should be determined whether its reconstruction or removal is necessary. From our perspective, the latter alternative is preferable. The second issue is the road crossing over the branch itself.

Figure 4.17 Difference in riverbed sedimentation between 2006 and 2014 (Google maps)

At present, the non-functioning sluice causes a rise of water of about 0.5 m. If the level above the sluice is 111.0 m then below the sluice and mill the level is 110.4 m above sea level.

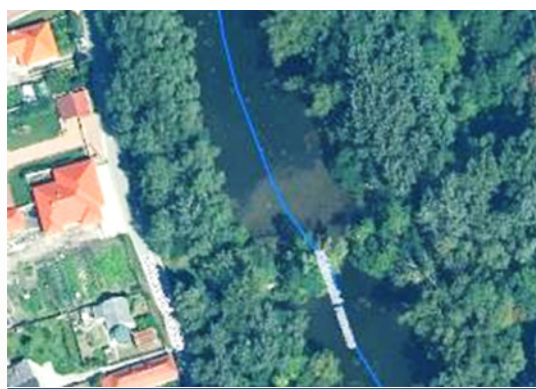
Further beyond the current the bridge are the ruins of the previous the bridge and cause a large obstruction to the flow of water in the section.

Figure 4.18 A flow blockage formed by the ruins of an old road bridge on the stream

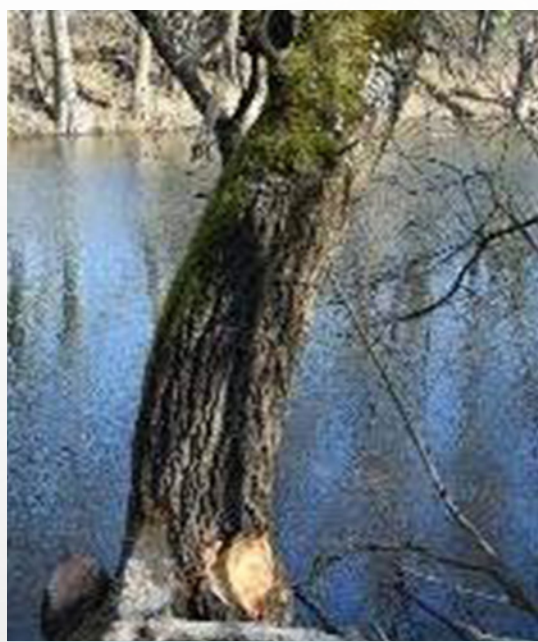
Beavers have settled on the riverbank side and are destroying the older growth there. They are not destroying the younger trees yet and are really only picking the thicker, thicker trees. Damaged of trees are in this section u dozens (hundreds).

Figure 4.19 Beaver activitie

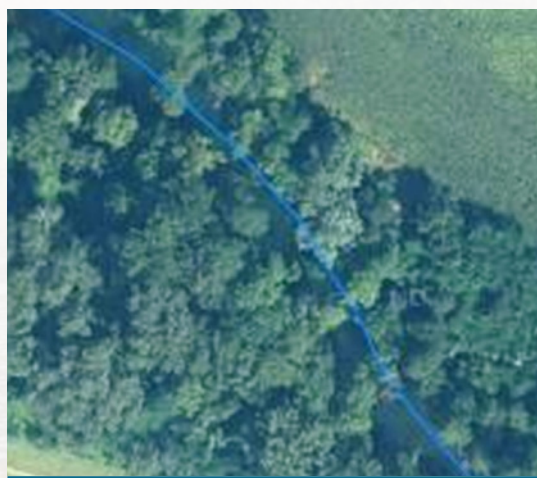
Figure 4.22 Stream dammed with fallen trees

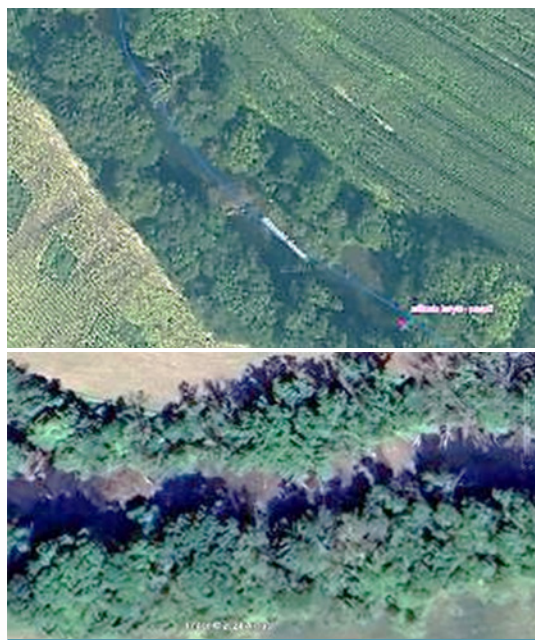
The riverbed is uniformly clogged and the stream channel in the riverbed is almost not developed. It is interrupted by dozens of fallen trees. The riverbed is slowly disappearing and even the flow rate is already very small.

Figure 4.24 Changes in riverbed siltation since 2006

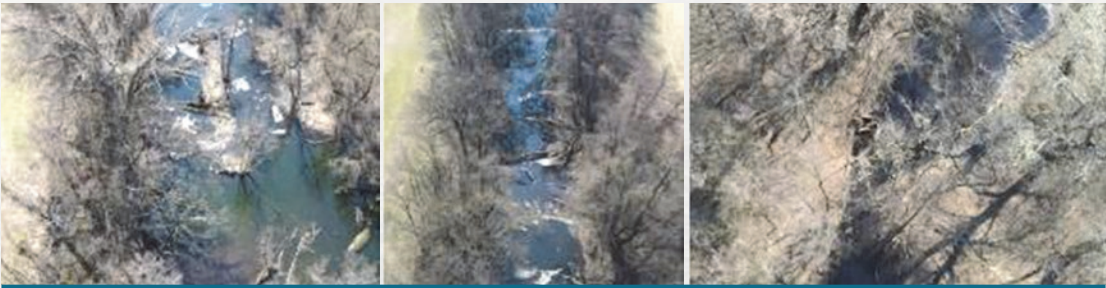
The riverbed at the beginning of section u is in very poor condition in terms of flow rate. Its width has been reduced again and the dropped trees are able to dam the whole riverbed. This causes sediments to be deposited in micro islands and also creates small

Figure 4.27 Problematic flow points in this section of the stream

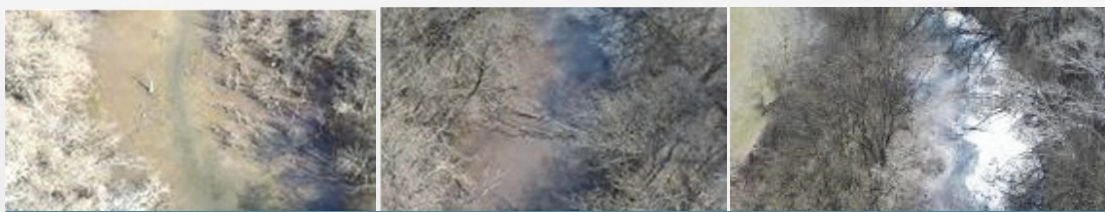
Figure 4.28 Problem flow points in streams with significant pollution

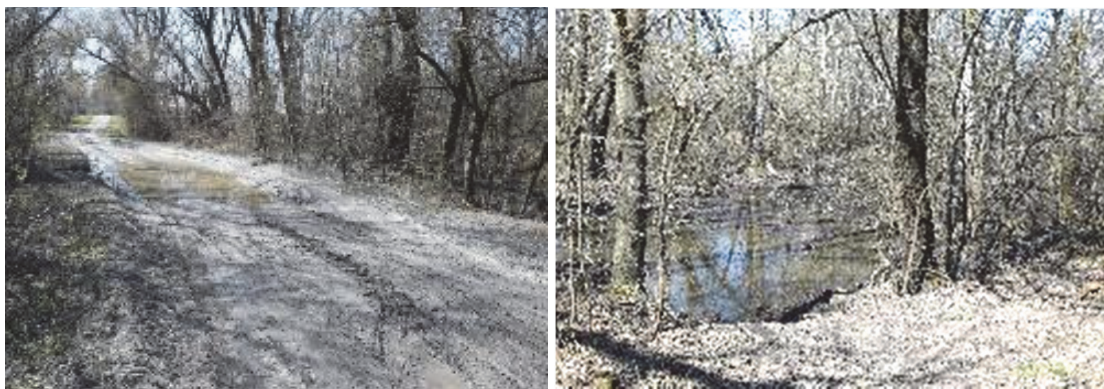
Figure 4.29 Problematic dirt road with a spillway crossing a stream without a culvert

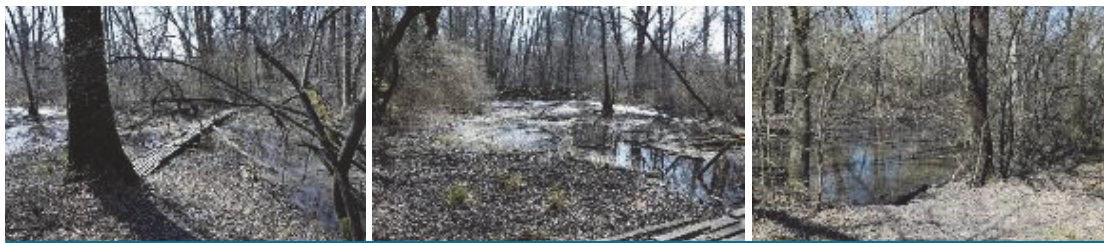
Figure 4.31 Problematic flow points in a stream with wetland habitat

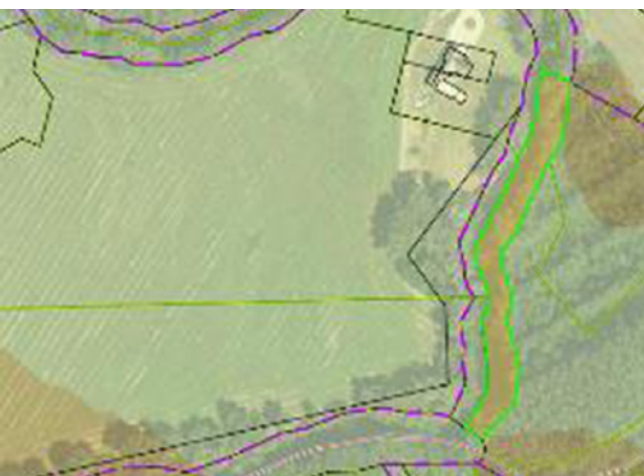
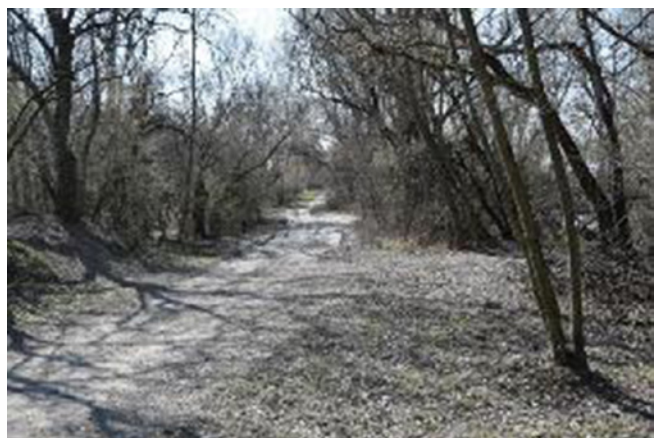
Figure 4.32 Problematic point of flow in a stream created by an embankment for a dirt road
