Landscape-Ecological Study of the Area of European Importance

SKUEV0075 Klátovské Branch

**IMPROVEMENT OF THE WETLAND
CONDITION OF THE KLÁTOVSKÉ BRANCH NPR
ON THE TERRITORY OF SKUEV0075**

Ľuboš Jurík et al.
Nitra 2024

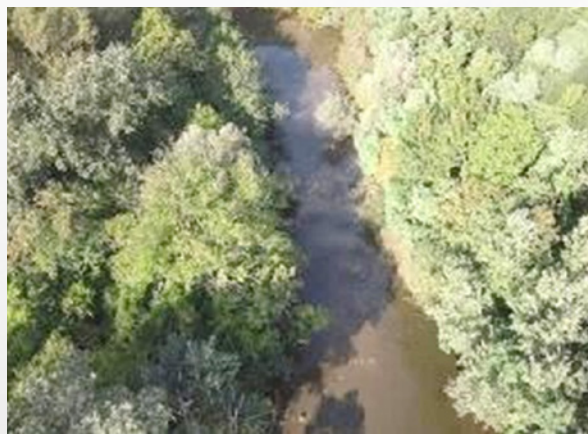
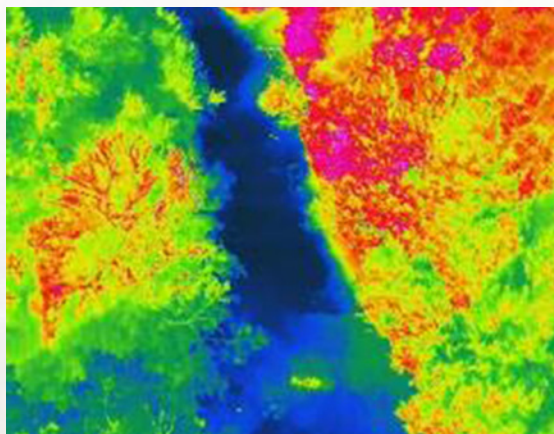
Figure 3.4 Aerial and thermal image of shallows

But the thermal image of the shoals shows their disadvantage. The excavated parts overheat more and consequently the water in the surroundings. In the previous images, they clearly stand out as warmer areas in the thermal image, and the light blue colour of the water is significantly warmer than the subsequent deeper the Water shown in dark black. The trees themselves are the warmest in the image and their cooling function is quite weak. The Evapotranspiration of trees even sufficiently supplied with water is not able to cool the surrounding air as it is usually reported for greenery in cities.

In Figures 3.5 the vistream bottom is an advanced riverbed clog with a large width and a small velocity. The riverbed siltation is so large that the first trees have taken hold here. Trees are the warmest in the riverbed

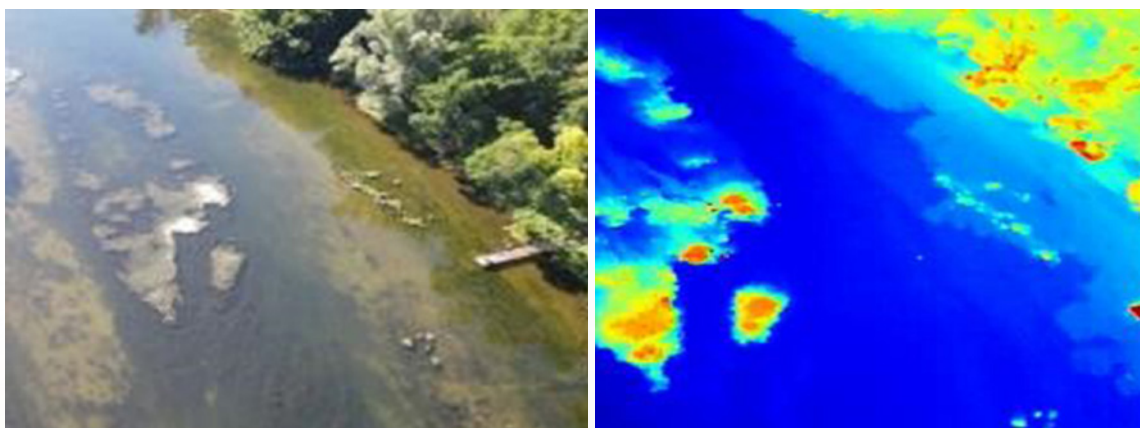
Figure 3.6 Temperature effect of aquatic plants on space temperature

and shoals are overgrown with plants similarly. The cooling of parts of the stream is due to two factors. It is the shaded part of the surface and then of course the depth of water.

In the upper images, the temperature effect of aquatic plants on the temperature

of the space and of water itself is clear. Unshaded shoals overgrown with aquatic plants cause an increase in the temperature of water by absorbing thermal radiation.

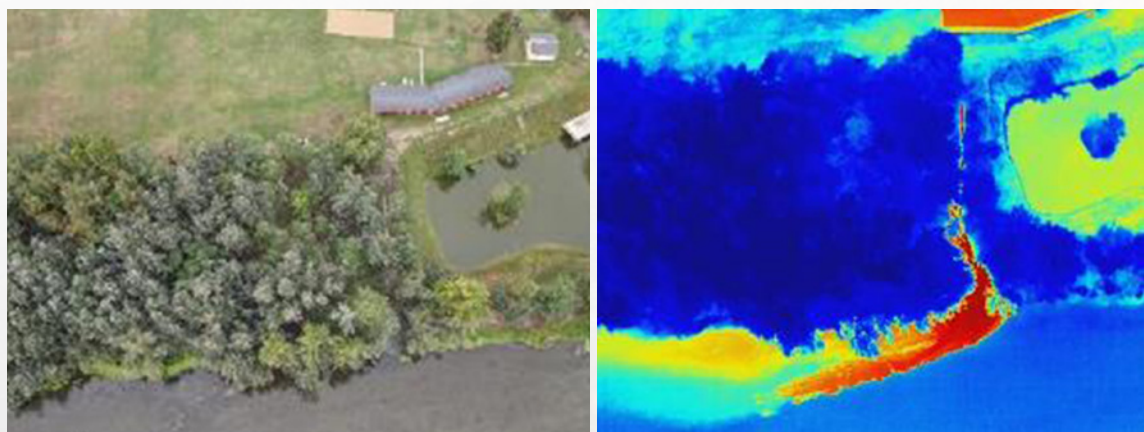
Figure 3.12 Aerial and thermal image of the outflow of water from the Topoľníky Thermal Baths

In the figures, there is a difference between a visual survey of water discharge, where thermal changes cannot be identified, and thermal imaging, where we can see not only temperature changes but also their areal changes.

The heat trace then extends far from the source and changes the living conditions

of the organisms in the water. This research provided the very interesting information. Some of the results are presented in another section of the document. The results of the survey from the thermal bathing area showed large thermal pollution over distances almost up to the fence object from the discharged warm of water.

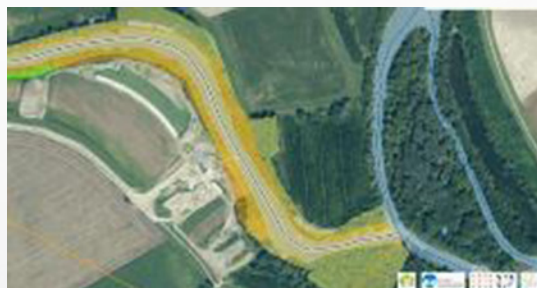
The riverbed in this section has a balanced width. Only Management of vegetation on the new the island is needed. At the end of section there is already native riverbank vegetation in need of intervention after falling into the stream.

The concave riverbank is quite silted in and a parallel band of vegetation is created parallel to the regular riverbank. Sediment should be removed here.

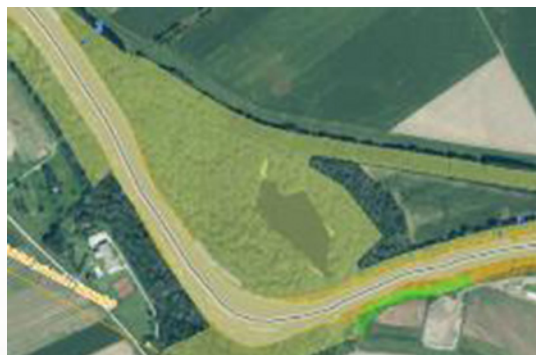
This section is leading riverbed channel to the village of Topolníky. This section at the channel has the highest flow rate in the reach because it is section just below the Gabčíkovo Topolníky channel outlet.

Management of both vegetation and sediment is required at the section. The concave riverbank is quite silted in and a parallel band of vegetation is created parallel to the regular riverbank. Sediments are gradually silting up the concave riverbank and this is also due to increased vegetation growth in the warm water flow. Throughout section the mixing zone discharges warm water from the thermal swimming pool and just upstream of the Riverbanks Branch there is increased vegetation growth due to the consistently high temperatures throughout the year. The warm water progression and mixing zone in the stream is very heavily overgrown and can be seen in the following figure.

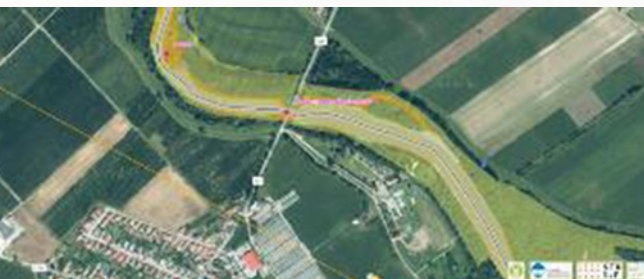
On the section there is a road the bridge on the state road number 561. This bridge, like other transverse obstructions, creates major impediments to both the flow of water and the movement of sediments.

The road bridge constructed in this area circa 1965 has significantly interfered with the flow regime of water in the riverbed and has reduced the flow area to less than half.

Extensive shoals have formed in front of and behind the bridge. If gravel were placed on these sections it would create a zone with a positive cleansing effect and prevent the putrefactive decomposition of organic

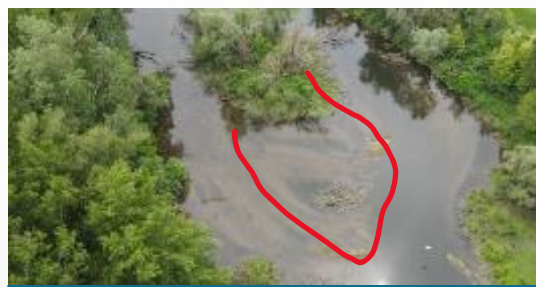
Figure 4.2 Proposed location of the islands extension to place sediments

At a distance of about 75 m after the bridge, the island with vegetation has already formed and behind it a shallow zone and just before a slight arch to the right is another area with sediments.

This and similar the islands should be used for Management of sediments. Wood stakes would be hammered at the edge of the siltation as shown in the figure and sediments from the shallow parts of the stream would be moved into the space thus created. This will create a better flow of water and will not change the natural character of the riverbed. The sediments will be naturally covered with shrubs or trees and create new protected nesting opportunities for birds.

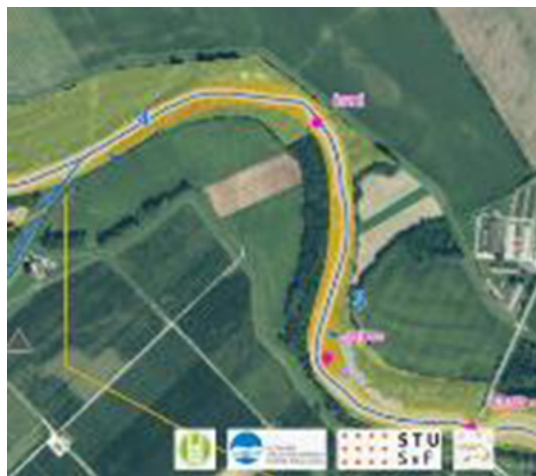
The flow of water in the arch brings an unequal distribution of velocities across the riverbed and this has been reflected in the riverbed

condition in this section. Almost half of the original flow profile is already clogged with sediment.

The critical condition is in the section of the arch at the top of the figure where the sediment deposits almost completely dam the flow rate in the reach. This condition is probably related to the tributary water from the Gabčíkovo – Topoľníky channel, whose quality is significantly different compared to the quality of water in the arm itself and this causes increased sedimentation. River bed in arch with alluvium forming extensive the island.

At this section, future upstream bottoming is needed to detail the rate of sediment development and the potential for fish barrier formation.

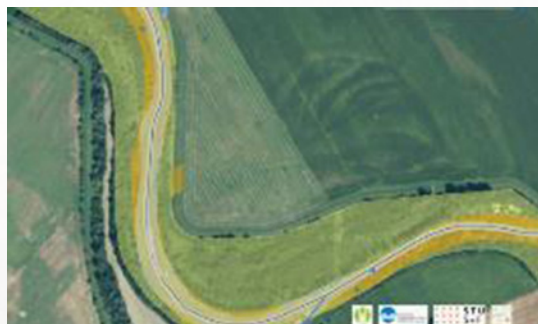
This section is of great importance for the branch. In km about 4,072 there is a tributary of Gabčíkovo – Topoľníky channel on the right side. It is a very important tributary because the basis of the flow rate is the seepage of water from the feeder channel to Gabčíkovo and the channel flows not only through intensively used countryside but also through many villages.

The difference in the quality of water in the chanel and the branch is significant and therefore the quality of the water in the Klátovské branch deteriorates after the confluence. This is also visible from the drone imagery.

Siltation has shifted the water flow into the concave riverbank as evident in the figures. From this kilometre onwards, wooden fishermen's piers are located on the concave

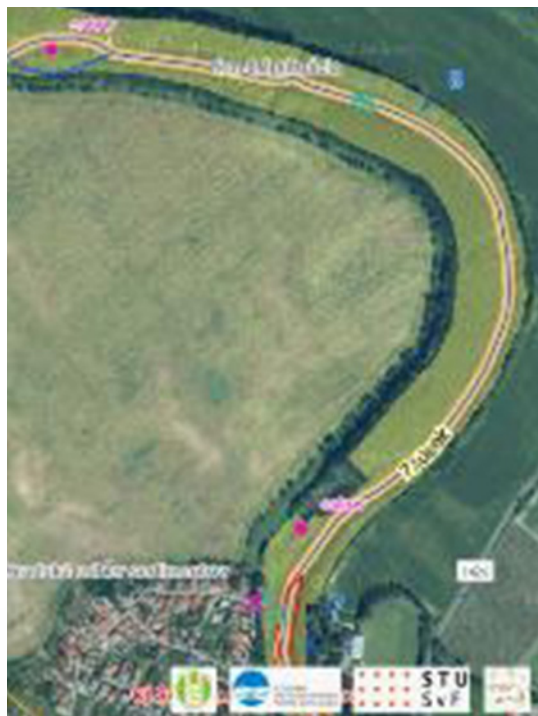
Figure 4.7 Proposed solution for moving sediments in the riverbed and creating gravel benches

In such a narrow part of the stream, dropped trees, which are increasing in number, are already becoming a significant obstacle.

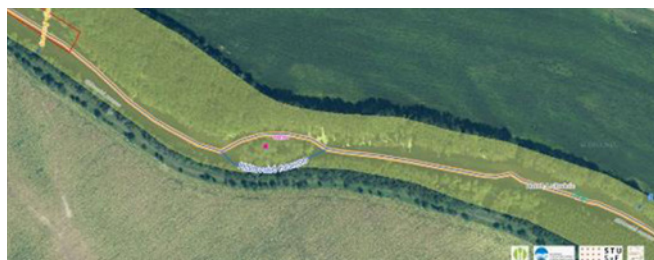
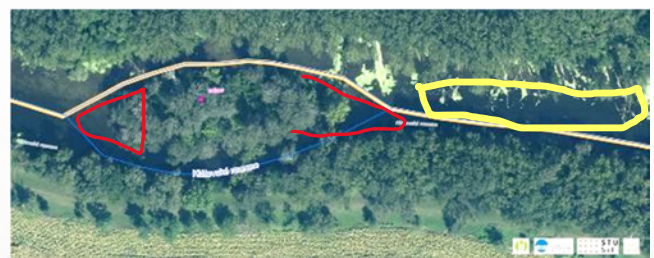
Figure 4.9 Proposed solution for moving the sediments in the riverbed to the existing the islet in the riverbed

The width of the riverbed is about 50 m and is fairly shallow with several areas of emergent plants. The riverbed is dammed several times by fallen trees.

One of the most critical sections in the first third of the stream. Large number of fallen trees on the left riverbank. They took up over half the width of the riverbed. Slowing of flow rate resulted in the creation of one of the islands. Need to reroute and relocate some of the fallen of trees to restore flow of water throughout the profile. Sediment management should use some of the dead wood to re-shape the islet in the center of the riverbed and then move some of the sediment into this area to create

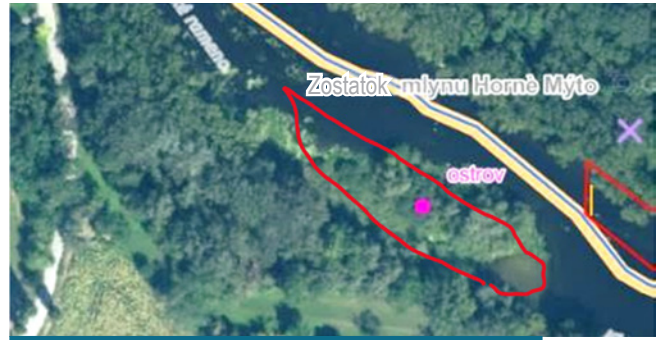
Figure 4.10 Proposed solution for moving the sediments in the riverbed to the existing the islet

On the opposite side, a large the island has been formed by siltation and over time it joins the right riverbank of the stream. This will

reduce its habitat importance for threatening nesting birds.

The island needs to be reshaped to create a bypass and space for management of sediments as suggested in the previous figure. The base of the change in form of the island should give a relocated deadwood to retain sediments.

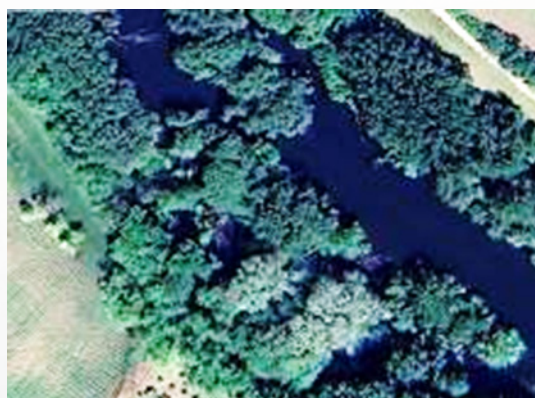
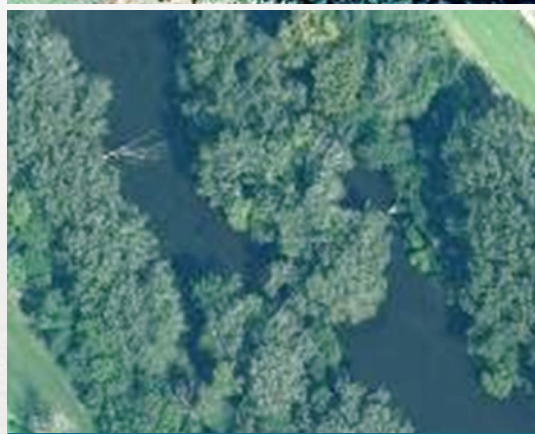
Figure 4.14 Difference in sediment volume between 2012 and 2023 (Google maps)

The slowing of the water in front of the bridge has created an almost complete closure of the riverbed by siltation. This is very significant siltation and the new fallen trees are making the situation even worse.

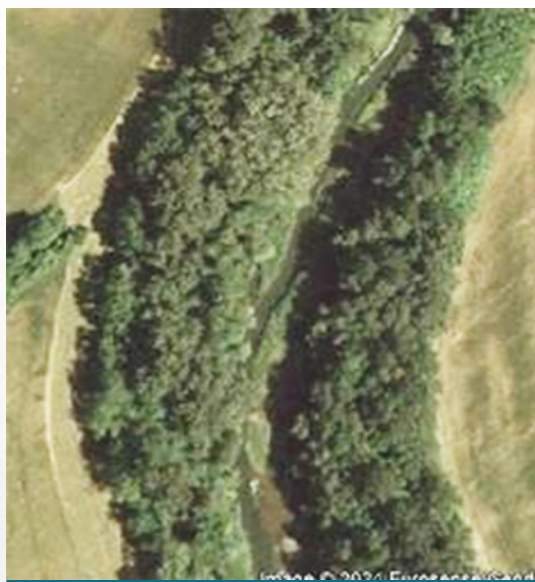
Figure 4.16a Difference in sediment volume between 2006 and 2014 (Google maps)

Again, comparing the situation in 2006 and today, the differences are substantial and are evidence of the need for revegetation interventions, even in a Level 5 conservation area.

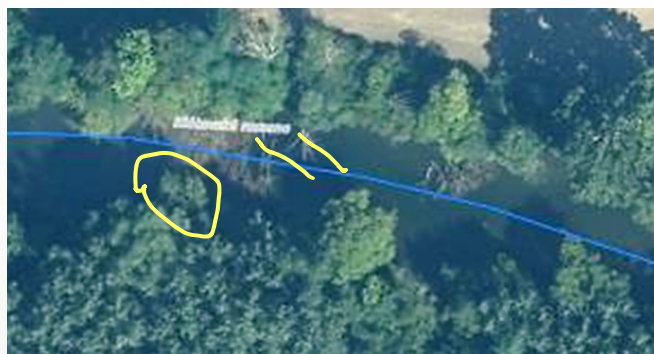
Figure 4.20 Problematic site with a lot of fallen trees

In the center of the ark is another problematic spot where fallen trees have nearly dammed up the riverbed. Trees have fallen against the sweeping flow of water. Therefore, they need to be moved so that they are in the direction of the flow of water.

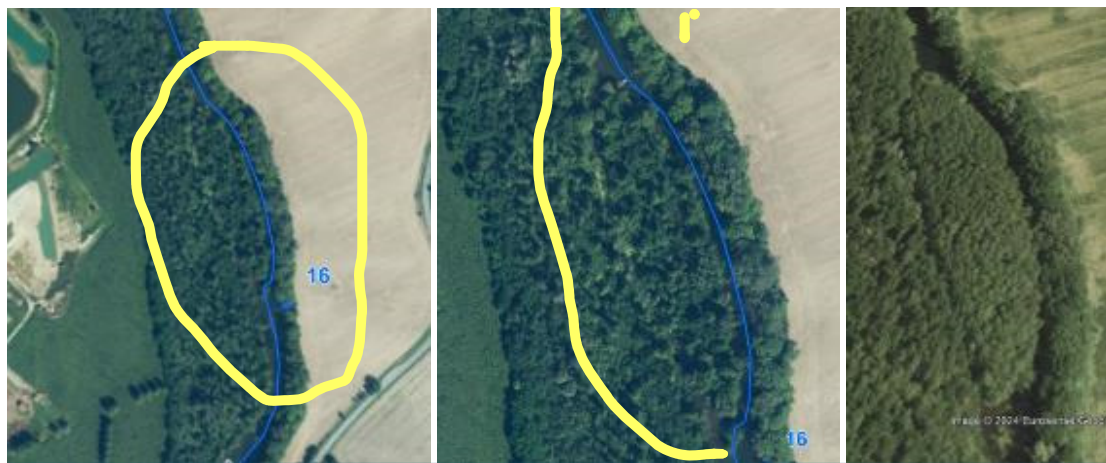
Figure 4.21 Changes in the state of the section from 2006 to the present

In section u is the already lost area the island, which after the clogging of one part became just an interesting sheet. The water is still moving in the original flow section on the right side of the sheet but this flow rate is very slow. In the 2006 image the flow rate on the right side is still clear.

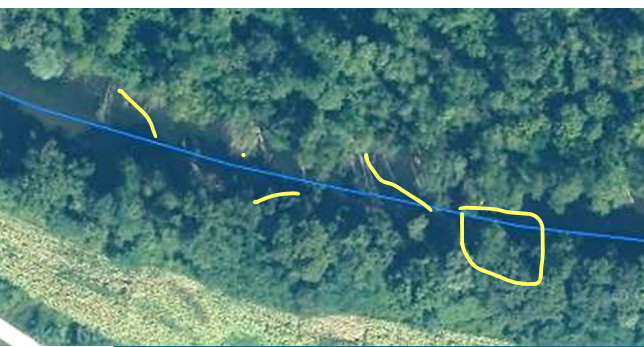
Figure 4.23 Management of fallen trees by redirecting them

There are a number of fallen trees in section u and since the stream is already narrower, tall trees are damming almost the entire riverbed. As a measure there is only management of fallen trees by redirecting them.

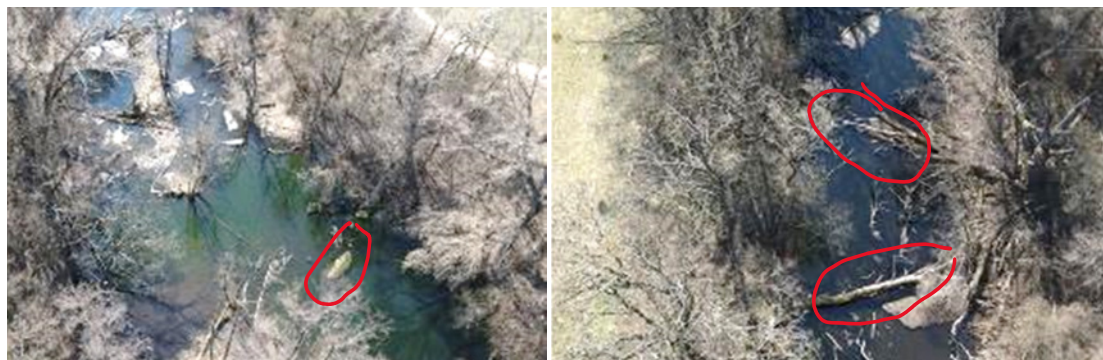
Figure 4.25 The need for sediment and tree management

The riverbed forms a section ending in a short meander. The overall condition of the riverbed is very poor. The flow in section u is almost stopped. This has two causes. There is a spillway forming a dirt road to the land on its north side. The spillway was created by an unprofessional practice some time ago and only two pipes of about 600 mm diameter are fitted at the flow rate.

If management of sediments and of trees is not done in this section, the flow rate in the riverbed will come to a standstill in a few year.

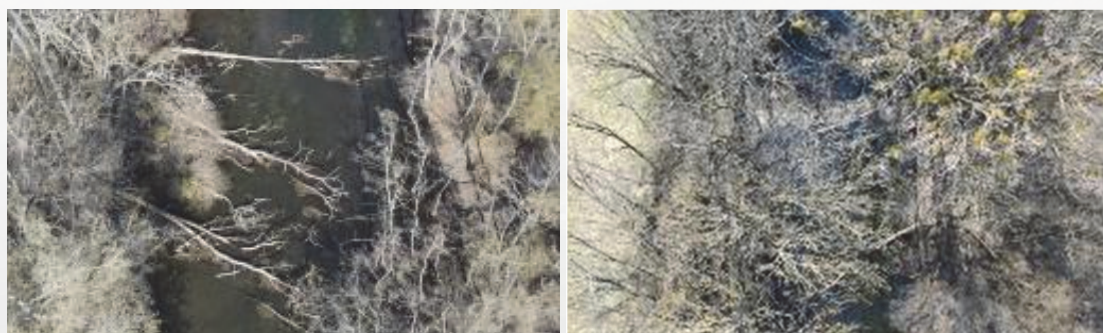
Figure 4.26 Need management sediments and of trees and wooden bench in the stream

The second problem is really the extreme amount of fallen of trees and their branches, leaves. Their impact is not only on the flow rate but nowadays also on the quality of water in the section, because the captured material is subject to decomposition, often anaerobic, releasing both sulphate and methane into the water. We have also observed decaying leaves and plant debris in the site, which, because of the abundance, were only decomposed by fungi and moulds and released unwanted substances into the of water.

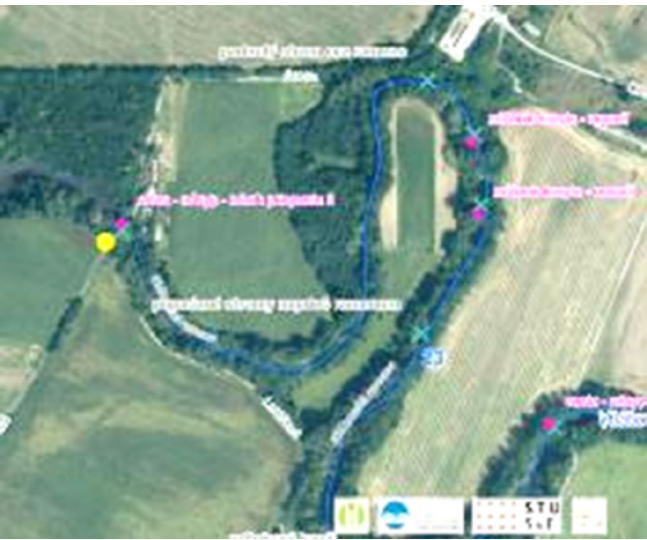
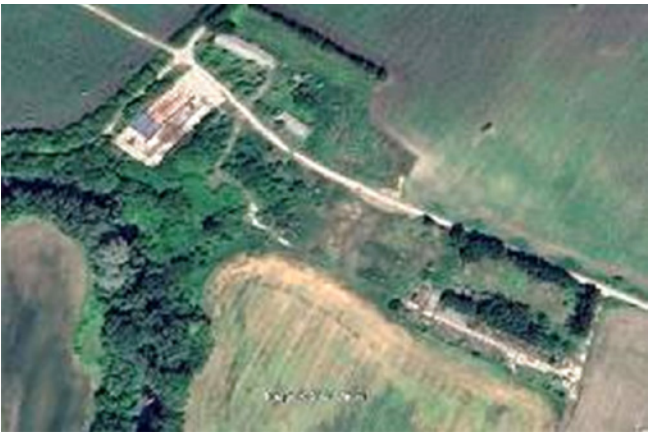
The slopes here are quite high and these constrictions are natural. Nevertheless, they severely restrict the flow in the riverbed due to their blockage by trees and branches fallen from trees.

The riverbed at the beginning of section u is in very poor condition in terms of flow rate. Its width has been reduced again and the dropped trees are able to dam the whole riverbed. This causes sediments to be deposited in micro islands and also creates small

The basic problem is as in the previous section with the extreme amount of fallen of trees and their branches, leaves. Their impact is not only on the flow rate but also on the quality of the water in the section because the captured material is subject to decomposition, often anaerobic, releasing both sulphate and methane into the water. We have also observed decaying leaves and plant debris in the site, which, because

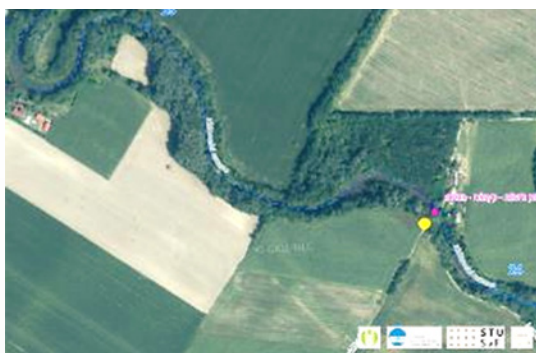
Km 24.0–25.0

The stream continues to narrow in this section and its width is only about 15 m or less. Due to the age of the trees on the riverbanks, the stream is almost completely shaded and the trees have a major influence on the character of the section.

The steady flow rate in the Klátovské Branch also ends at this section. From this point onwards we can speak of a wetland section rather than a watercourse.

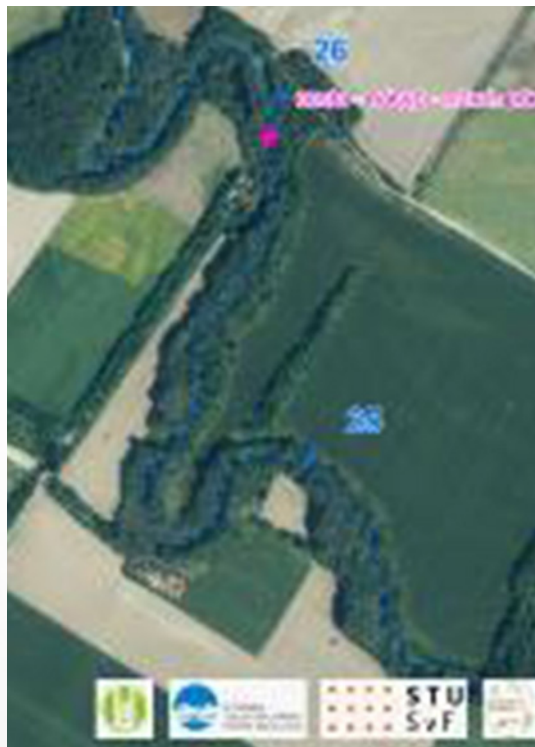
Km 25.0–26.0

At the beginning of the section at the first settlement the riverbed widens to 40 m and then narrows to 15 m.

The water in section u changes colour seasonally. The golden algae (*Chrysophyta*) are seasonal in the water and are not hazardous apart from signalling a deterioration in the quality of the water.

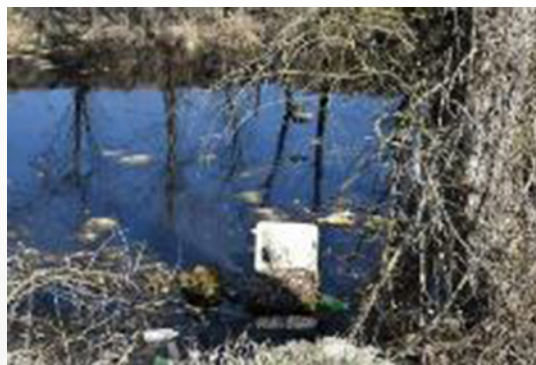
The road through Klátovské Branch itself is in a very bad condition. Above the road a pond with shallow and very polluted water has formed. Just before the damming of the stream there is an inhabited settlement. On the other - north side of the Branch there are remnants of the meandering of the stream in the form of pits which have a level of water corresponding to the level of water in the Klátovské Branch and this place is in the third level of protection as a protection zone of the Branch but it is more of a municipal waste dump. Although this site is about 5–6 km away from the village it is still interesting for disposal of inconvenient waste.

Figure 4.30 Places near the arm threatened by human activities – waste

It is necessary to urgently make a road out of the spillway, with a hydraulically and technically solved culvert. It endangers the Klátovské Branch itself from the beginning of its flow rate and other parts of the riverbed are thus impassable.

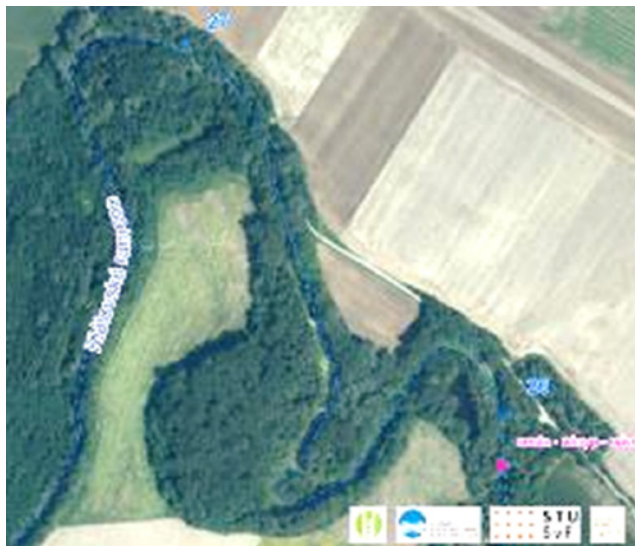
Km 26.0–27.0

The entire riverbed branch is practically hidden in the forest cover. As it is in the water map, the section no longer has continuous water and especially the beginning of the section u is already a wetland section and there are more species surviving waterlogging but only occasional flooding. The water shows more wetland decomposition processes and often the putrefactive process of decomposing organic matter. Unfortunately there are few waste sites in the section. The vicinity of the branch is designated as Bödör.

There are no technical buildings in section u but there is a pedestrian crossing over a shallow wetland and it is probably used by hunters.

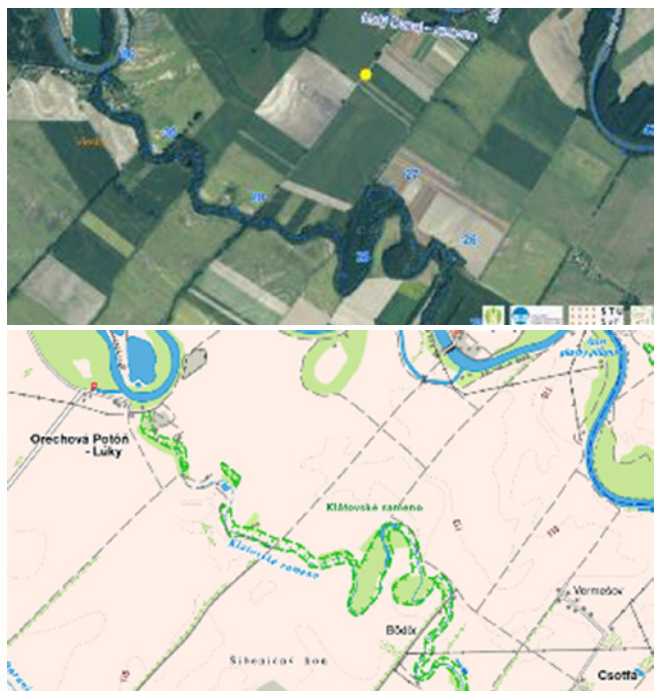
Km 27.0–30.6

Klátovské Branch sections without water flow.

It is a section copying the forest cover inside the meander. Also this section has water only in some places. On the left is a new forest stand about 34–45 years old. Its composition is quite different from other riverbank or companion stands. It is primarily composed of Black Pine and Scots Pine with an admixture of Scots Oak.

River bed in this section u is with water only on a small section. The water is very shallow with visible pollution, e.g. with stains from petroleum products. Golden algae have multiplied on the bottom and the water has a putrid smell. The water is almost completely devoid of life.
